## 2023 CANADIAN CONSULTING ENGINEERING AWARDS

# Caribou Falls Block Dam 2 Reconstruction

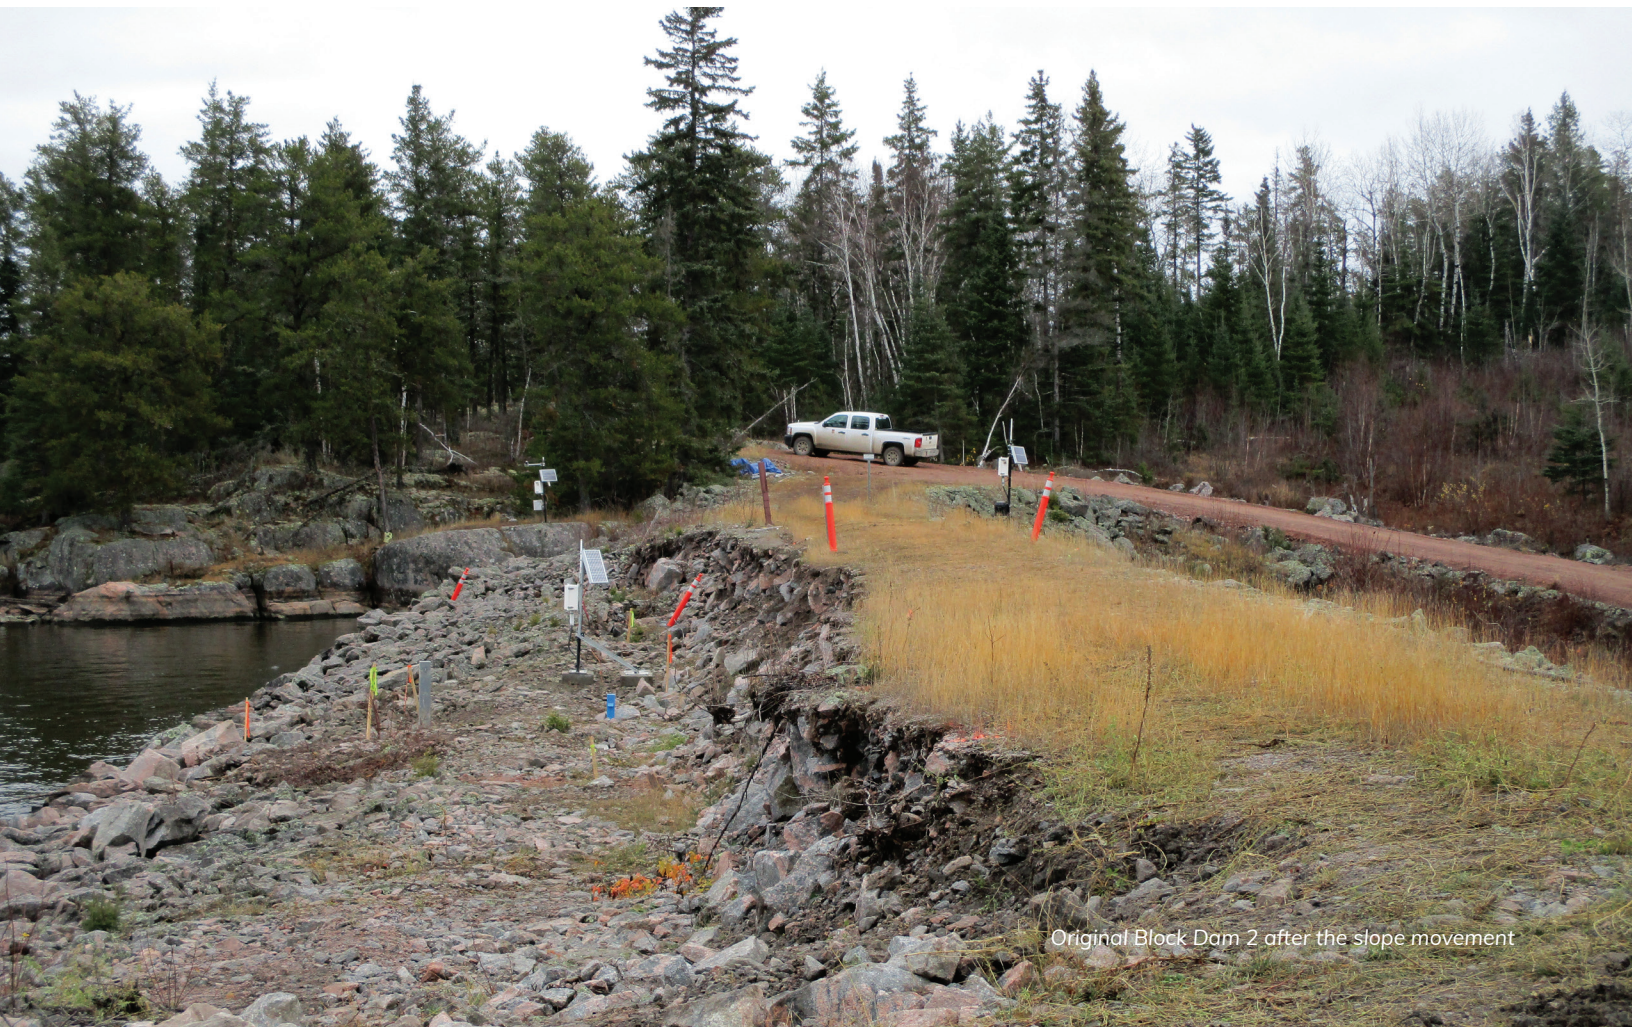
Original Block Dam 2 after the slope movement

After approximately 60 years since its original construction, significant movement suddenly and unexpectedly occurred on the slope of Block Dam 2. The upstream half of the crest dropped approximately 1.5 m in the eastern section of the dam, exposing internal fill materials and potentially compromising the integrity of the core beneath. For safety reasons, OPG lowered the headpond which resulted in lost power generation capacity. OPG immediately began an intensified surveillance and monitoring program. Investigations and studies to understand the root cause of the slump were initiated and remediation measures were explored.

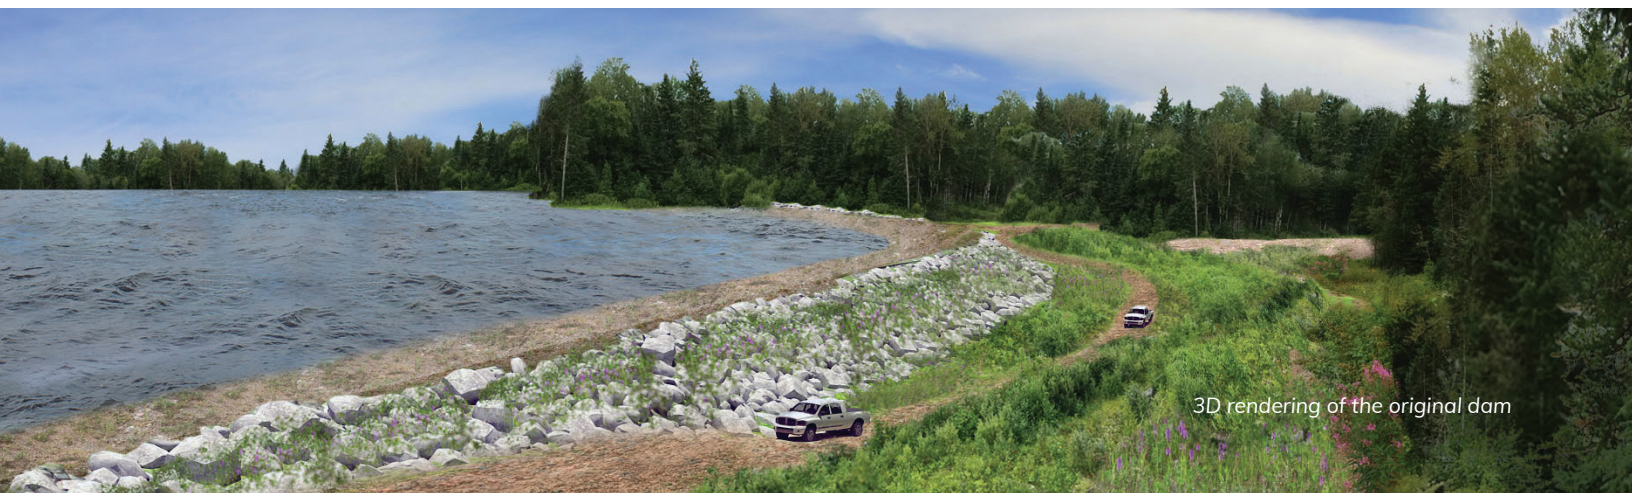
3D rendering of the original dam

KGS Group modelled the new dam superimposed over a digital terrain model (DTM) of the original ground surface in a simulated 3D environment using Autodesk Civil 3D software. This tool enabled accurate material and resource estimates, fully automated and quick regeneration of the model and quantities for each design iteration. It also facilitated 3D renderings of the finished product for open house material to support consultation with the WIN community. To support construction, the model files were uploaded directly into Kiewit's GPS controlled equipment fleet for accurate and efficient implementation of the design.

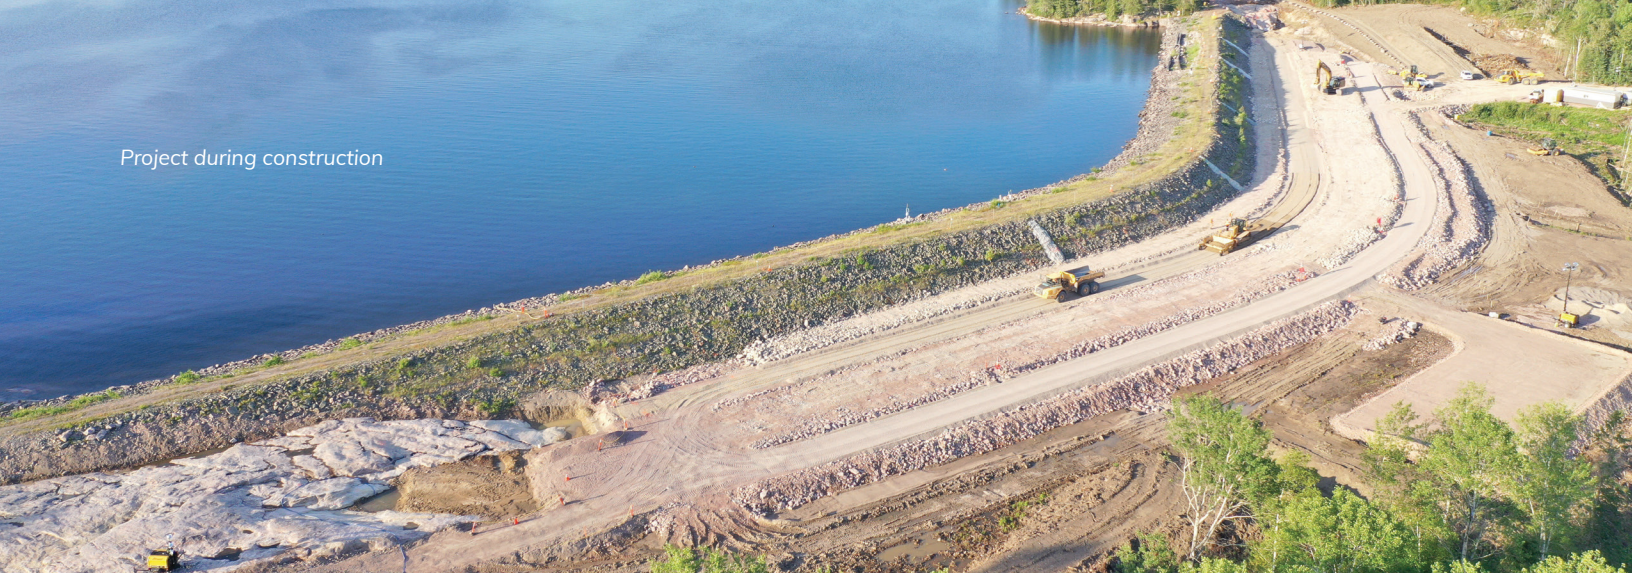
Project during construction

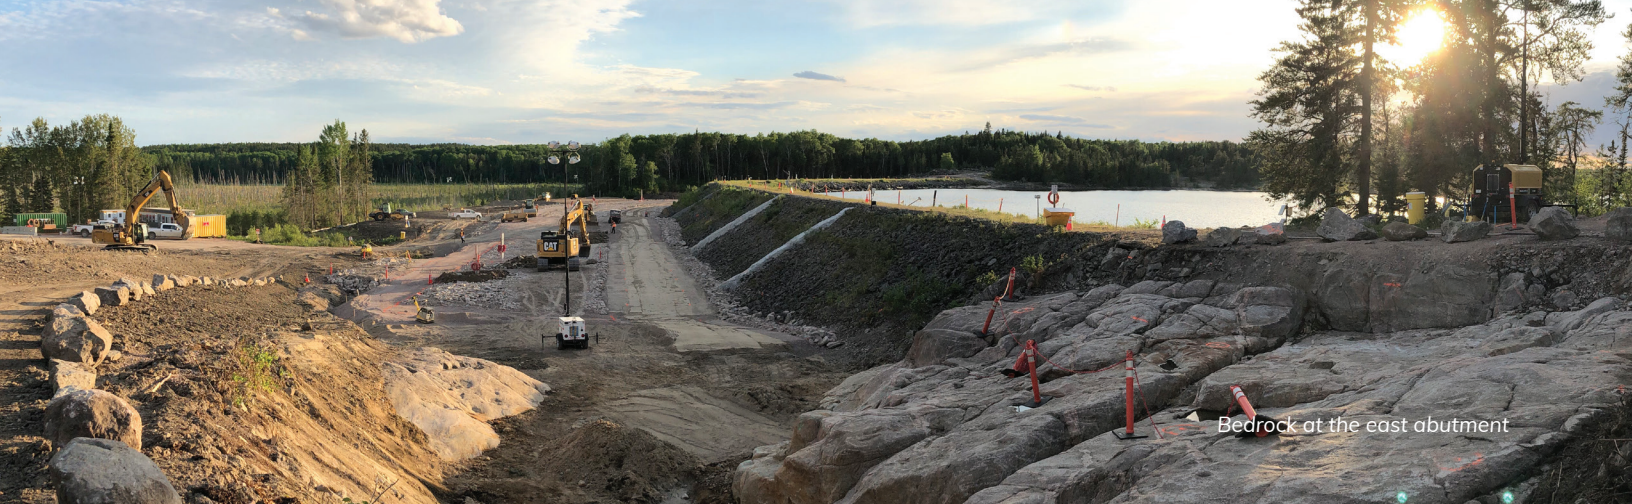
Bedrock at the east abutment

Upon stripping the overburden and exposing the east abutment, it became clear to the team that the Precambrian granitic bedrock surface and jointing was more irregular and problematic than anticipated. This area was originally covered in coarse shot-rock which is impenetrable to seismic refraction surveys and impossible to drill through. The east abutment was highly irregular with sub-vertical faces and a 15 cm wide open fracture that could create a preferential seepage path through the abutment. The team reacted immediately to minimize impacts to the already tight schedule. Kiewit provided a topographic survey and digital surface superimposed over a georeferenced air photo taken from a drone that Kiewit had dedicated to the project. The data was expedited to KGS Group's design team who immediately prepared the required design change that optimized the dam alignment and narrowed the core detail to avoid the irregular surfaces. A customized grouting program was designed to infill the open fracture and make it watertight.

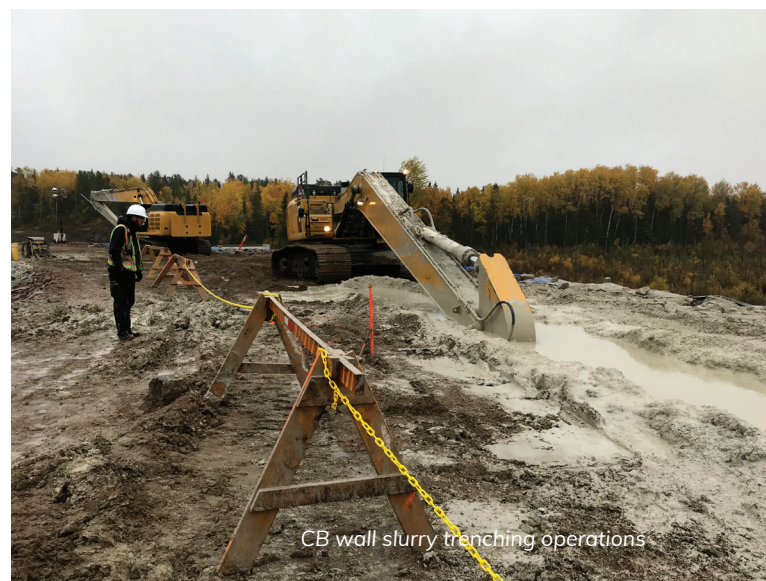
CB wall slurry trenching operations

CB wall construction needed to happen around-the-clock as the slurry was progressively curing. To maximize the distance between the agitation created by the excavator and the hardening slurry to avoid permanent damage, the slurry trenching had to proceed on schedule. The geotechnical investigations revealed that dense cobbly granular layers with sporadic boulders existed in the eastern section. To avoid the risk of getting stuck in these coarse materials with a conventional excavator bucket, Kiewit reinforced its fleet with two 49-tonne long-reach excavators equipped with three interchangeable implements: 1) The multi-ripper bucket with a series of offset teeth attached to a narrow bucket that was used to tear through dense gravel and pluck out boulders; 2) The hoe-ram, resembling a large jackhammer, dynamically impacted and broke up solid rock; and 3) the hydraulic drum-cutter with two sets of rotating carbide teeth that was designed to “chew” through reinforced concrete. Once the dense layers were removed, a standard bucket was used for bulk slurry trenching to form the CB wall.

Even with the diverse set of tools at the team’s disposal, the tough ground conditions in the east area pushed the two heavy machines to their maximum capacity. Equipment break-downs, dense cobble zones, and boulders up to 1 m in size made for some tense moments, as this was the team’s one chance to build this critical dam element through this area. After ten long and strenuous days and nights, Kiewit successfully made it through, and continued to complete the entire CB wall after three more weeks.

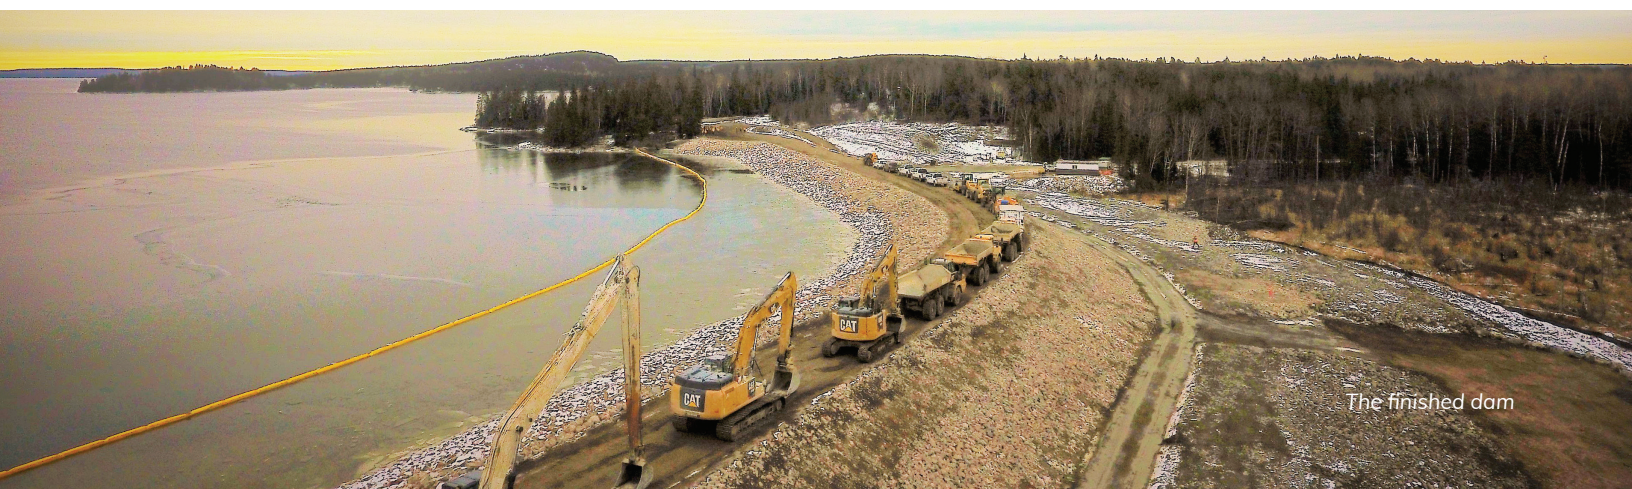
The finished dam
